PRELIMINARY ASSESSMENT

METLAKATLA PENINSULA

Prepared for
Metlakatla Indian Community

Prepared by
Ridolfi Engineers and Associates, Inc.
Seattle, Washington

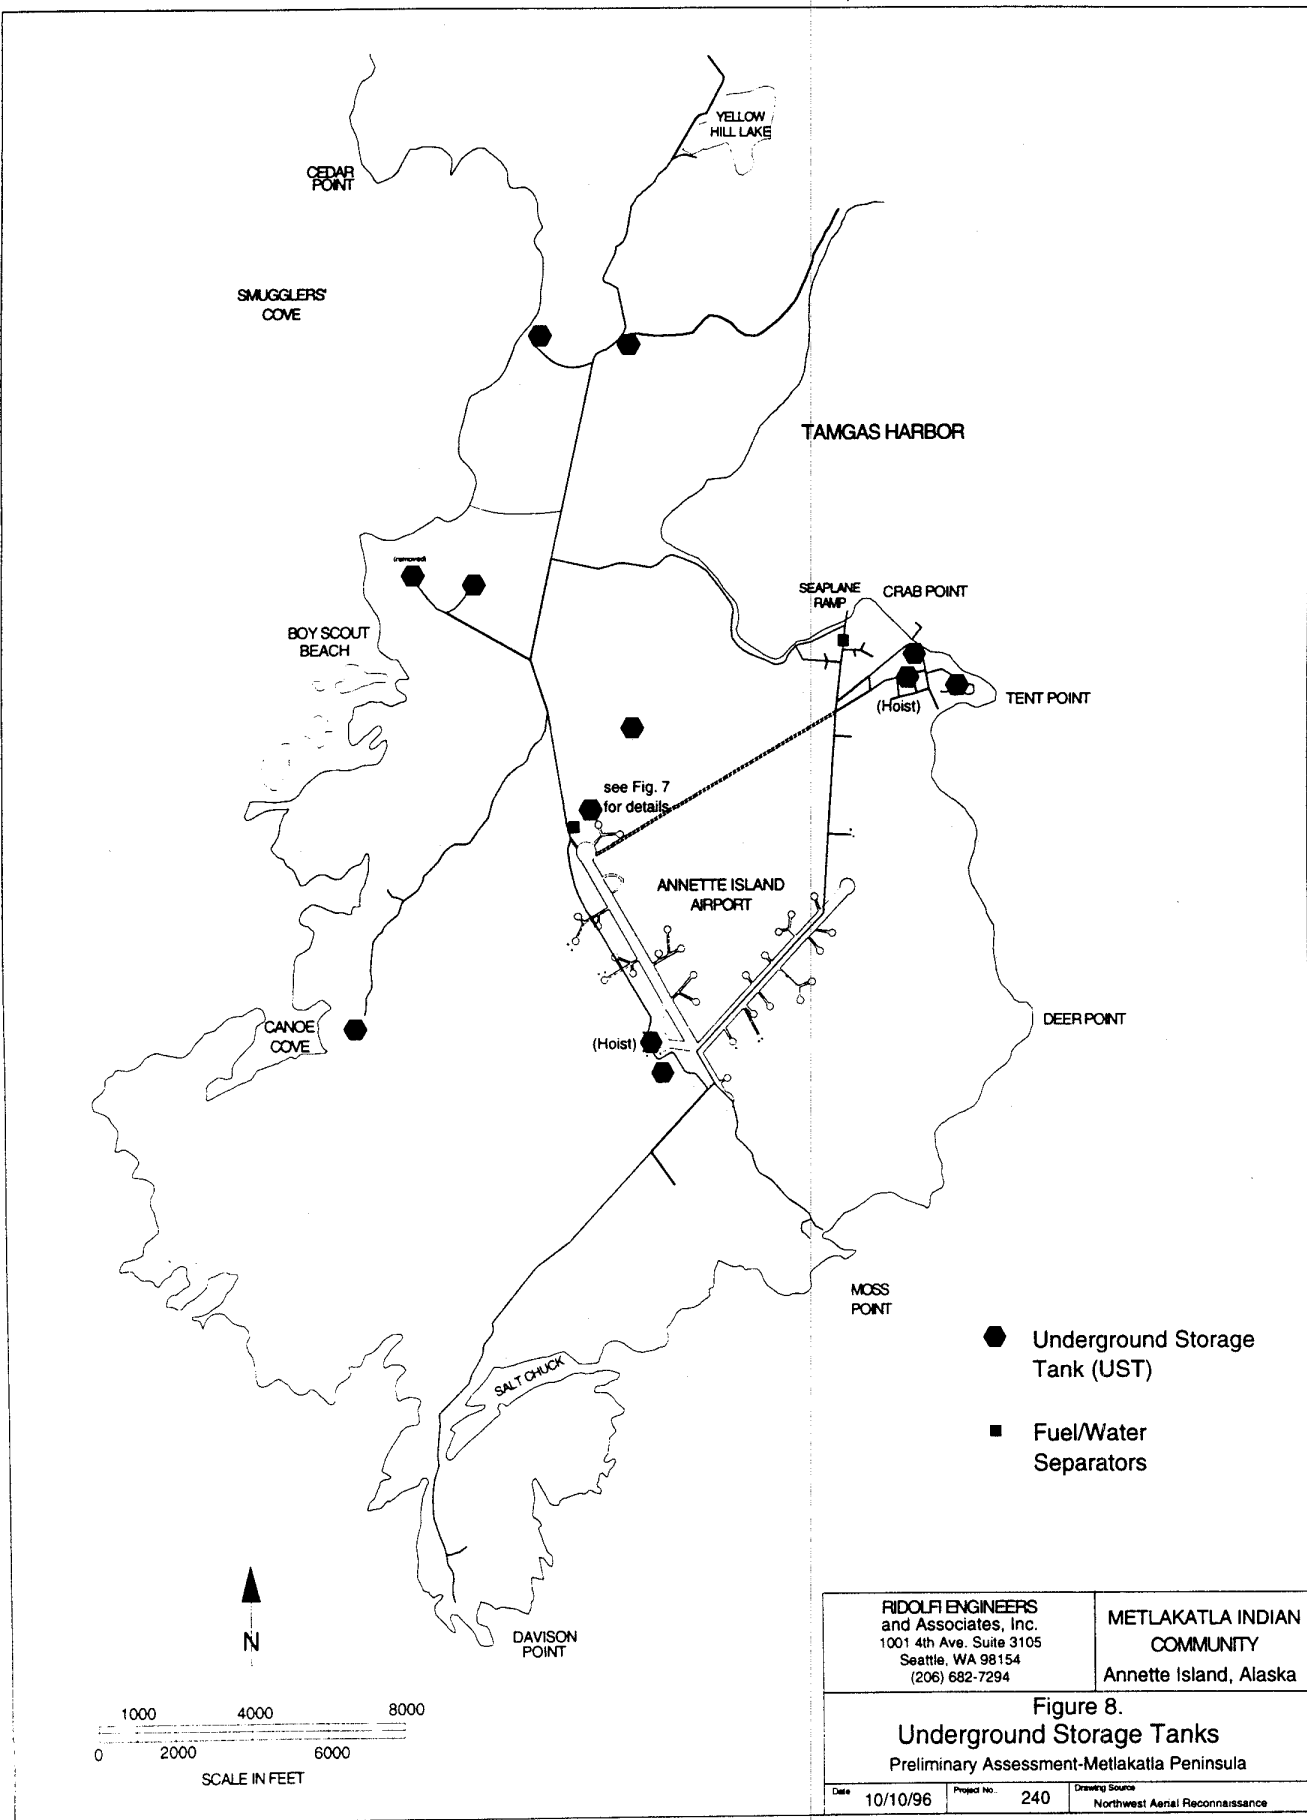
Figure 8 shows the location of USTs at the project site. USTs ranging from an estimated 300 gallons to 50,000 gallons in size were confirmed in place at the following locations:

South of the BIA Road Maintenance Center (7)
 White Alice Station (15)
 Remote Control Air Ground (RCAG) Facility (21)
 USCG Housing (44)
 VORTAC Facility (27)
 FAA Housing Area (53)
 Tactical Fueling Area (part of 39)

Fuel USTs are suspected be in place at the DOD/FAA gasoline station in the Main Construction Camp area and at a former Standard Oil gasoline service station southwest of the hangar. Hydraulic oil USTs are suspected to be in place at a hydraulic hoist in the hangar and at a former service center near the Main Construction Camp area. None of the USTs appeared to have been permanently decommissioned by in-place closure.

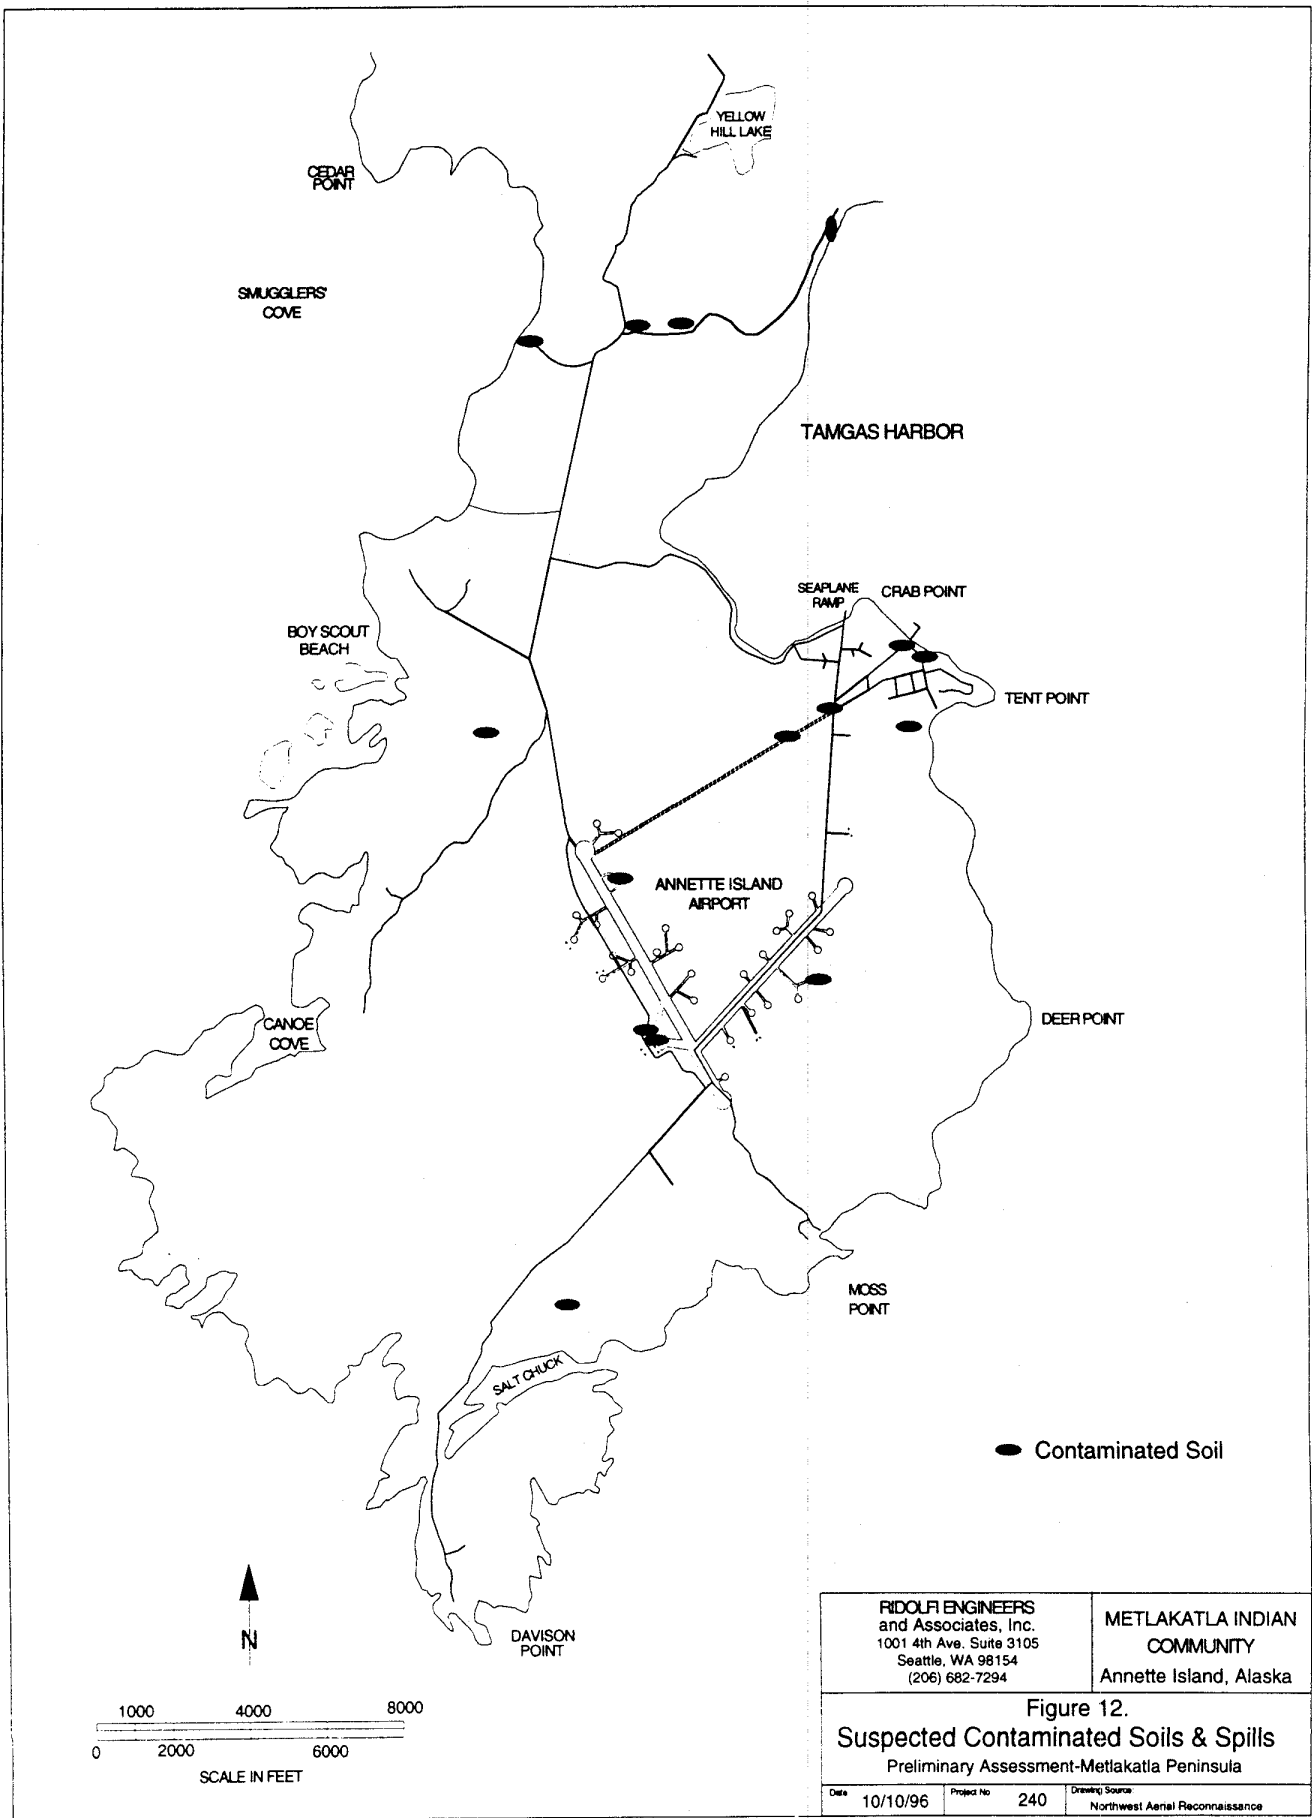
Figure 12 shows the locations of suspected contaminated soil and spills. Tar contaminated soil was noted at an area south of the BIA Road Maintenance Center (7) and at several other locations associated with the disposal of tar barrels. Areas of suspected petroleum hydrocarbon impacted soil were observed at the North Tamgas Harbor Tank Farm (12), the White Alice Station (15), north of the DOD Gasoline Station (49), the DOD tank farm south of the Main Construction Camp (48), at various points along the Fuel Pipeline System (39), and at the Microwave Receiver Station near Point Davison (85).

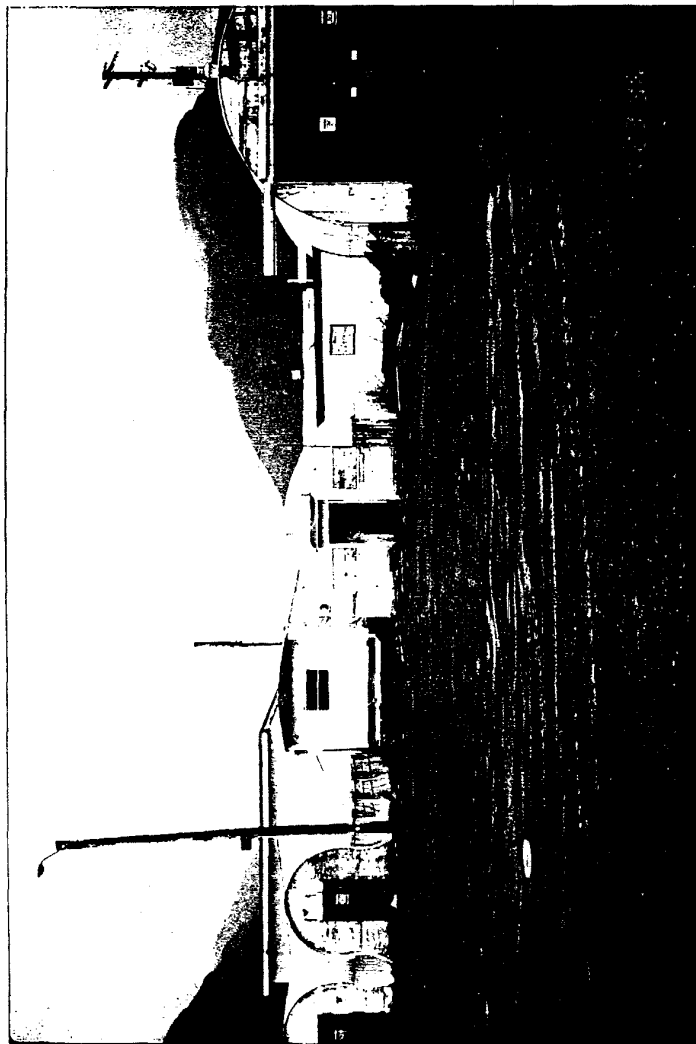
Photograph 7: BIA Road Maintenance Center

The operational road maintenance center contains approximately 10 small metal hut housing offices and road maintenance equipment in a 300-foot x 350-foot work area (see photograph). Discarded above ground storage tanks, 55-gallon drums, stained soil, and tar-coated soil were observed. Two USTs are located approximately 250 feet south of the road maintenance center. A layer of tar covers the soil overlying the USTs.

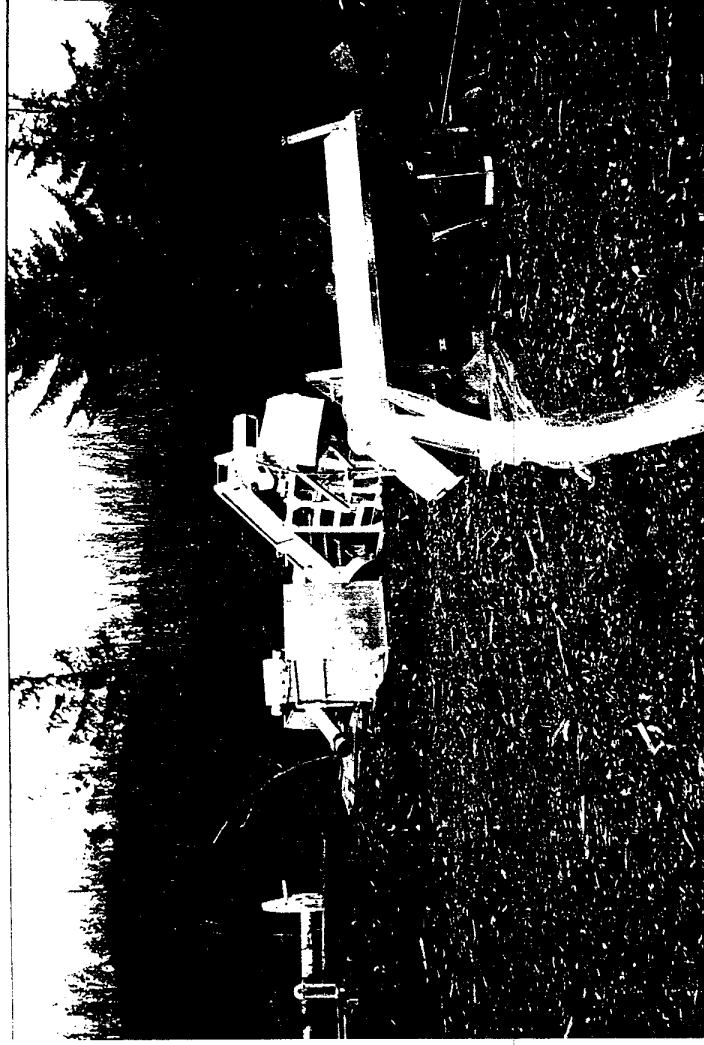
Photograph 8: Bark Disposal Fill Area

The surface dimensions of the bark disposal fill area is approximately 400 feet x 800 feet. Sixteen above ground storage tanks and miscellaneous metal debris (see photograph) were observed on top of the fill area.

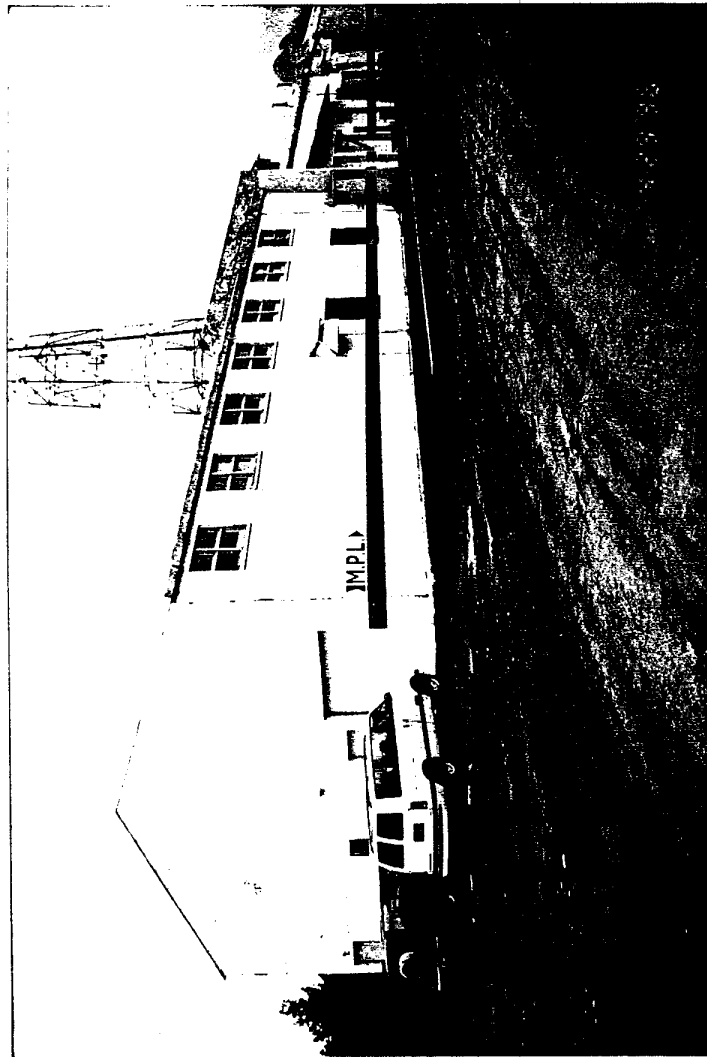
Photograph 15: White Alice Station

The former White Alice Station consisted of a 50- foot x 350-foot, two-story building (see photograph) and two large metal communication relay receivers. It was constructed by the U.S. Air Force in the late 1950s. The building is currently utilized as offices for Metlakatla Power and Light. Three fuel ASTs, one water AST, three fuel UST fill ports, numerous 55-gallon drums, numerous transformers, batteries, remnants of the White Alice microwave receivers, and a large orange communications tower were observed around the building. Soil staining was observed in proximity to the UST fill pipes, 55-gallon drum storage, and transformers.
